# Diagnostic Investigation of the Building Materials and Conservation Proposals of Al-Ashraf Khalil Mamluk Mausoleum Dome - Historic Cairo - Egypt

Historic structures,  
Mamluk mausoleums,  
Building materials,  
SEM-EDX,  
XRD,  
Conservation plan

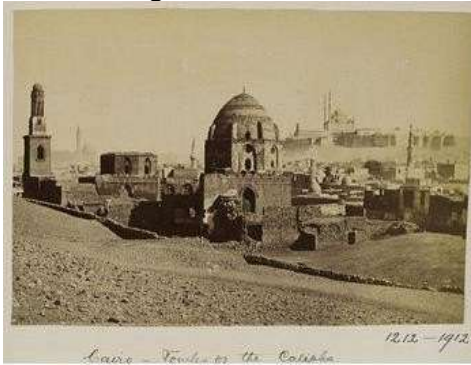
(a) The mausoleum of al-Ashraf Khalil (1912)

Figure 1. (a & b) Old and recent photos of the mausoleum of al-Ashraf Khalil.

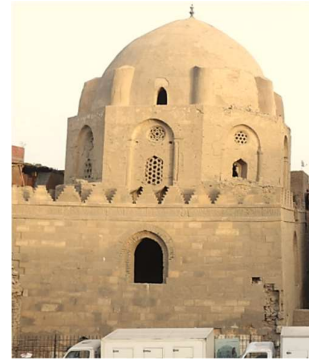
The mausoleum (Figure 1b) is essentially composed of a smooth cupola reinforced by vertical, cylindrical pillars reposing on a high octagonal drum. The walls supporting the drum are made of limestone, with recent restoration accounting for the differences in the color of the blocks. However, the dome and the drum are made of fired brick. The dome, which has an outside diameter of 11.3 meters(m), height of 6 m, and a wall thickness of 0.50 m, is supported by a curved plinth that, with the exception of the eastern corner, has almost totally vanished. The top of the dome has a slight taper which is tiered by cresting at its highest point. The dome has eight circular buttresses that alternate with four windows in a parabolic design. A drum octagon supports the dome and has an internal diameter of 5.2 m, a height of 6 m, and a wall thickness of 1 m. On the inside of the drum and below a series of circular widows are Surat a'l-Umran Naskh inscriptions (4:189-193) (Figure 2a). The straight walls below the dome are 14 m long, 1.9 m thick, and 10 m high. At the top of the external face of the walls is an inscription that glorifies sultan al-Ashraf Khalil (figure 2b). Figure 3a shows a plan of the

(b) The mausoleum of Al-Ashraf Khalil (2020)

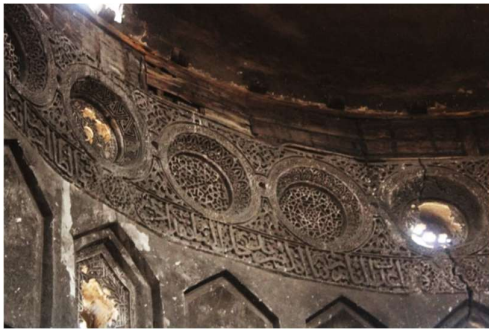
(a) Surat a'l-Umran Naskhi inscriptions (4:189-193) in the interior of the mausoleum.

Figure 2. (a & b) Inscriptions outside and inside the dome. (Taken by authors)

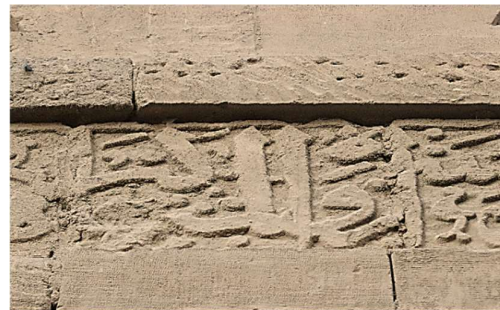
(b) The exterior inscription that glorify Al-Ashraf Khalil.

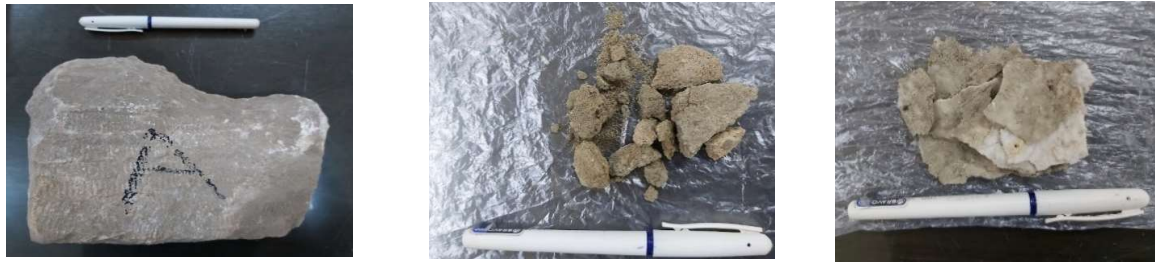
Figure 5. (a,b& c) Material samples collected from the mausoleum. (Taken by authors)

(a) Limestone sample (a 14 cm pen used as scale).

(b) Mortar sample.

(c) Salt sample.

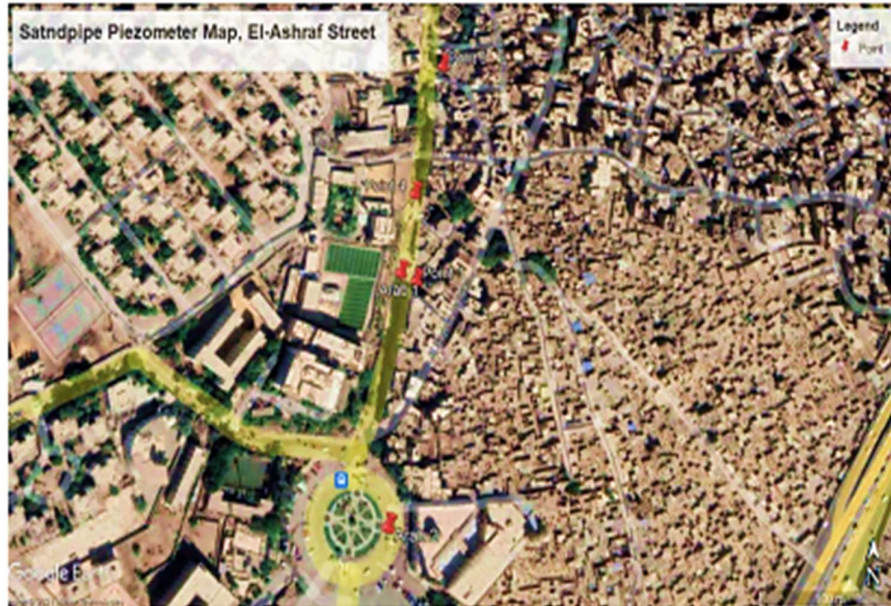
Figure 6. Locations of the piezometers (Marked with the red signs)

There are three piezometers located on el-Ashraf Street to monitor groundwater levels (figure 6). Three piezometers were installed at the location of the three executed boreholes. Therefore, the location of old piezometers that were installed by an earlier contractor were examined. Two piezometers were found, one of them was located near Piezometer No. 1.

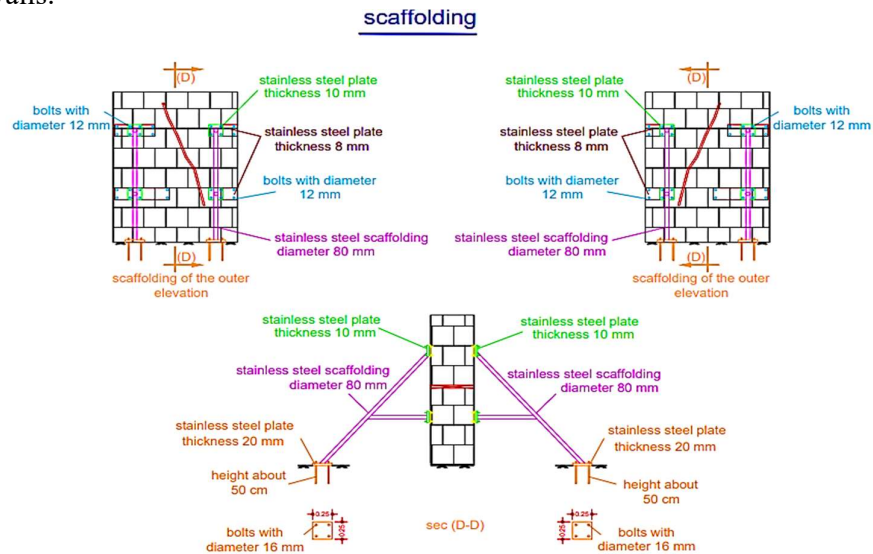
Figure 12. Shoring proposal for the inner and outer walls of Al-Ashraf Khalil mausoleum. (Made by authors)

the mausoleum are reinforced with appropriate shoring before the start of conservation work (Figure12). It was clear from the visual inspection that the walls are bulging and there are a lot of missing and friable stones, especially in the lower parts of the walls. Shoring of door and window openings may be achieved using wooden frames in order to remove the damaged doors and windows for conservation in a specialized workshop. A structural design for the shoring appropriate for this building needs to be formulated considering the weight of the walls as well as the dead and live loads supporting the walls.

1. Immediate structural interventions to keep the building from further deterioration or collapse. These measures are necessary to ensure the structural integrity of the building and the ensure the safety of the public. It is essential that the inner and outer walls of

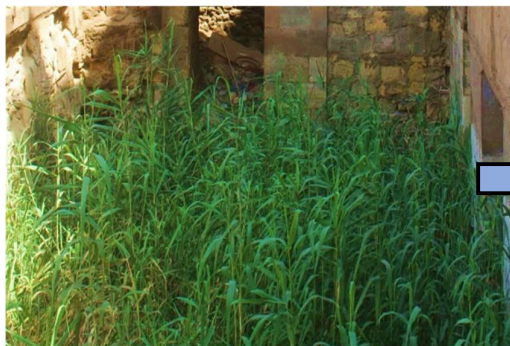
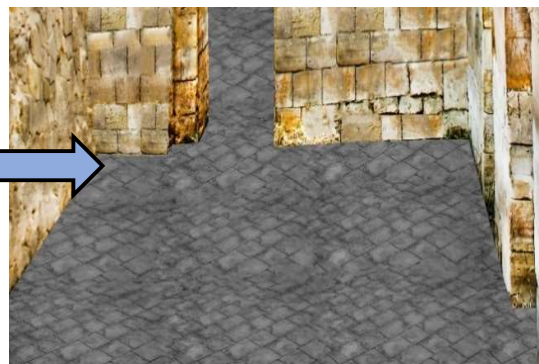
Figure 13. Current status and proposed restoration.

(a) Current status of entrance.

(c) Present status of corridor

2. The installation of a dewatering system such as portable pumps to lower the groundwater. In addition, all the vegetation and waste need to be removed from the site. These two steps are critical in order to proceed with the conservation treatments (Figure 13).

(b) Proposed treatment for entrance.

(d) Proposed treatment of corridor.
