# NANO TREATMENT OF DECAYED CEMENT-LIME MORTARS FROM THE EDFENA ROYAL PALACE (ROSETTA, EGYPT)

This article focuses on the identification of the used building materials and their most common degradation factors at the royal palace of king Farouk at Edfena, Rosetta, Egypt; and then assessing the most appropriate nano-consolidants for the decayed lime-based mortars at the palace, to achieve the target of this study; building materials were studied by means of XRD, FTIR spectroscopy and light optical microscope; in order to find out if there are any chemical decomposition or any physical failure. Halite salt was detected in the building limestone; mortars' composition varies between lime and white Portland cement, while the plaster in the palace walls is a mixture of white Portland cement and lime. Plaster in the marina is a mixture of lime, white Portland cement and anhydrite. Pigment material in the green terrazzo is a mix of malachite and greenalite; portlandite abreast with brucite were found in the plaster and mortar mixtures in addition to clay minerals. Nanolime, nanotitanium, nanokaolin, nanosilica and multi-walled carbon nanotubes were used as consolidants, experimental study

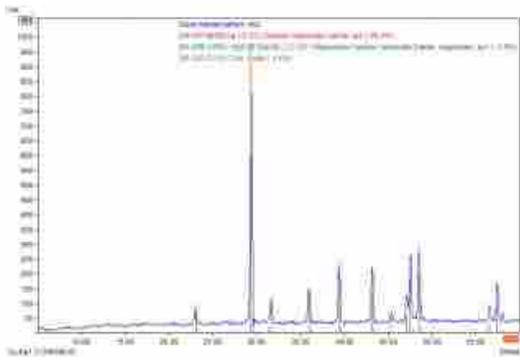
Figure 2: XRD pattern of the marina limestone sample reveals calcite as dominant component

**XRD Results:** Two limestone samples were analyzed from the palace; the first was derived from the marina of the palace and consists of 85% calcite (CaCO<sub>3</sub>), 9% dolomite [CaMg(CO<sub>3</sub>)<sub>2</sub>] and 6% halite (NaCl); (figure 2). The second limestone sample was taken from the northern wall of the palace and consists of 86% dolomite [CaMg(CO<sub>3</sub>)<sub>2</sub>]; and 14% calcite (CaCO<sub>3</sub>); (figure 3). Two redbrick samples were also examined by mean of XRD; the first is a marina sample and consists of 44% quartz (SiO<sub>2</sub>); 28% illite [KMgTiAl<sub>2</sub>Si<sub>3</sub>10(OH)<sub>2</sub>]; 22% hematite (Fe<sub>2</sub>O<sub>3</sub>) and 6% muscovite [KAl<sub>2</sub>(AlSi<sub>3</sub>O<sub>10</sub>)F(OH)<sub>2</sub>]; (figure 4). The second redbrick sample was taken from the palace northern wall and composes of 47% quartz (SiO<sub>2</sub>); 26% diopside (CaMgSi<sub>2</sub>O<sub>6</sub>); 17% calcite (CaCO<sub>3</sub>) and 10% hematite (Fe<sub>2</sub>O<sub>3</sub>); (figure 5). Concerning mortars; three mortar samples were analyzed; the first one represents the joints between limestone blocks; the sample contains; 71% calcite (CaCO<sub>3</sub>); and 29% quartz (SiO<sub>2</sub>); (figure 6). The second mortar sample represents the joints between the redbrick units and contains; 56% calcite (CaCO<sub>3</sub>); 34% quartz (SiO<sub>2</sub>) and 10% albite (NaAlSi<sub>3</sub>O<sub>8</sub>); (figure 7). The third mortar sample represents the bedding layer of the mosaics and the terrazzo inside the palace; the sample contains; 71% calcite (CaCO<sub>3</sub>); 17% albite (NaAlSi<sub>3</sub>O<sub>8</sub>); 6% quartz (SiO<sub>2</sub>) and 6% hematite (SiO<sub>2</sub>); (figure 8). The plaster was also analyzed to find out if it has the same chemical composition of the mortars or it is different. Two samples were examined; the first was

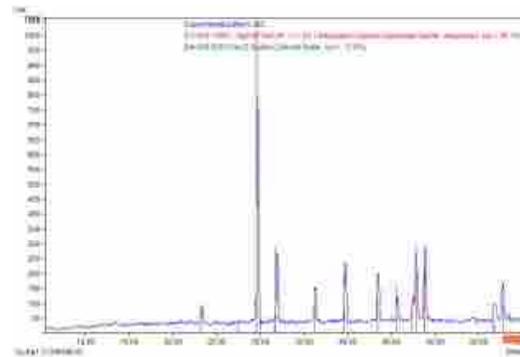
Figure 3: XRD pattern of the palace limestone sample reveals dolomite as dominant component

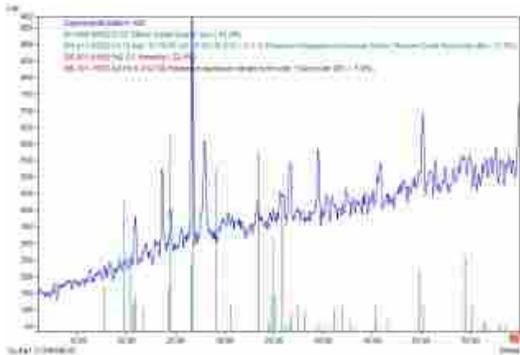
Figure 4: XRD pattern of the marina redbrick sample reveals quartz as main component abreast with illite

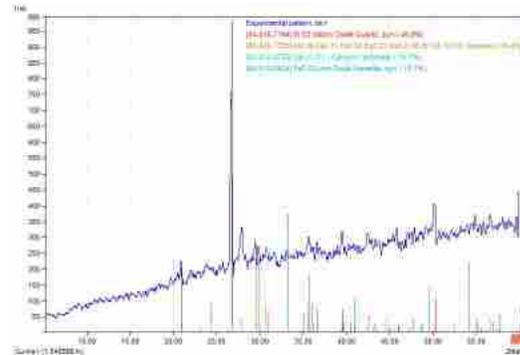
Figure 5: XRD pattern of the palace redbrick sample reveals quartz as main component abreast with diopside

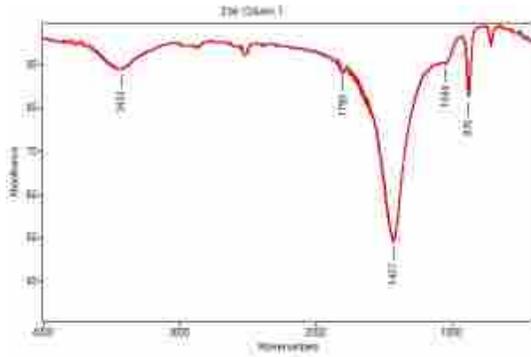
Figure 12: FTIR spectrum of the marina limestone sample

**FTIR Results:** compounds obtained from the XRD analyses were confirmed by the presence of their functional groups when analyzed using FTIR; limestone samples are mainly calcite (figures 12&13). This is emphasized by the presence of the characteristic bands of calcite: broad strong band at  $\approx 1427\text{ cm}^{-1}$  due to  $\text{CO}_3^{2-}$  stretching vibration, C=O stretching band of  $\text{CO}_3^{2-}$  at  $\approx 1799\text{ cm}^{-1}$  and O-C-O bending band of Carbonate group at  $\approx 875\text{ cm}^{-1}$ .<sup>17</sup> Small C-H stretching bands in the range between  $2924$  and  $2871\text{ cm}^{-1}$  are due to organic impurity. FTIR analysis of the redbrick sample from the marina (figure 14); shows that the sample is mainly silicate minerals, bands at  $1073$ ,  $783$  and  $460\text{ cm}^{-1}$  confirm this conclusion, bands at  $3440$  and  $1631\text{ cm}^{-1}$  represent bonded O-H stretching vibration and H-O-H bending vibration. The redbrick sample from the palace wall (figure 15); showed the strong broad band at  $3426\text{ cm}^{-1}$  represents bonded O-H stretching vibration. The band at  $1634\text{ cm}^{-1}$  is assigned to H-O-H bending vibration. The small stretching band at  $1435\text{ cm}^{-1}$  is due to  $\text{CO}_3^{2-}$  group indicating the presence of trace amount of calcite in the sample. Bands at  $1060$ ,  $780$  and  $461\text{ cm}^{-1}$  are assigned as Si-O-Si asymmetric, symmetric and bending vibrations respectively of quartz. Small C-H stretching band at  $2924\text{ cm}^{-1}$  is due to an organic impurity. Concerning the mortars; FTIR spectrum of the mortar jointing limestone (figure 16); shows the presence of the characteristic bands of calcite at  $1796$ ,  $1429$  and  $874\text{ cm}^{-1}$  in addition to that of quartz at  $1080$ ,  $788$  and  $464\text{ cm}^{-1}$ , while the mortar jointing redbrick (figure 17); showed the vibrations of calcite ( $\text{CaCO}_3$ ) peaked around  $1432$ ,  $873$  and  $712\text{ cm}^{-1}$  assignable to  $\text{CO}_3^{2-}$  group. Bands related to quartz and silicates around  $1080$ ,  $786$  and  $453\text{ cm}^{-1}$  are also identified, third mortar sample (Terrazzo mortar-figure 18); shows the presence of a strong broad band around  $1430\text{ cm}^{-1}$  in addition to two bands at  $1796$  and  $875\text{ cm}^{-1}$  proving the presence of calcite. The spectrum shows also the presence of a very broad band in the range  $1082 - 1053\text{ cm}^{-1}$  assignable as Si-O stretching plus the two bands at  $788$  and  $465\text{ cm}^{-1}$ . These bands are related to quartz and silicates. Bands at  $2929$  and  $2868\text{ cm}^{-1}$  are due to an organic impurity. As for plaster; the sample taken from the palace walls (figure 19); shows the same results obtained from the mortar analysis, while the second plaster sample (figure 20); shows the vibrations of calcite,  $\text{CaCO}_3$ , peaked around  $1432$ ,  $873$  and  $712\text{ cm}^{-1}$  assignable to  $\text{CO}_3^{2-}$  group were identified. FTIR spectrum of the terrazzo sample (figure 21); shows the presence of Si-O stretching bands in the area  $1100-900\text{ cm}^{-1}$  confirming the characterization of silicates. Calcite bands are also present at  $1427$ ,  $1799$  and  $879\text{ cm}^{-1}$ . The IR bands at  $3684$  and  $3452\text{ cm}^{-1}$  correspond to OH frequencies (silanol group, Si-O-H) while the IR band at  $1638\text{ cm}^{-1}$  represents H-O-H bending vibration of water.

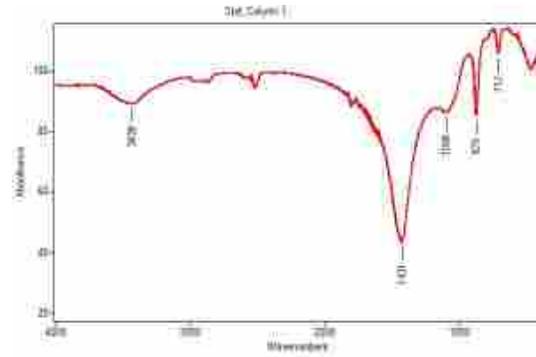
Figure 13: FTIR spectrum of the palace limestone sample

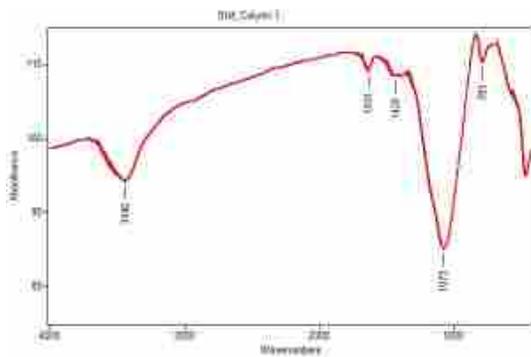
Figure 14: FTIR spectrum of the marina redbrick sample

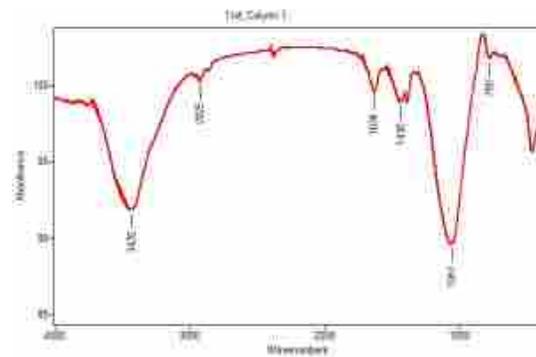
Figure 15: FTIR spectrum of the palace redbrick sample

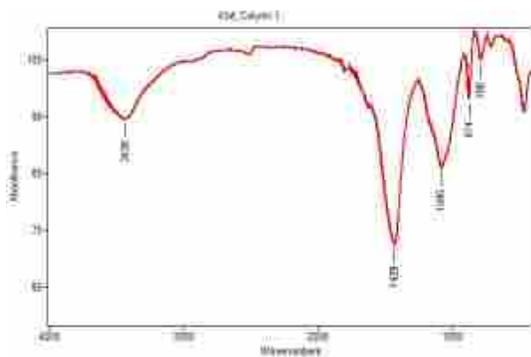
Figure 16: FTIR spectrum of the limestone mortar sample

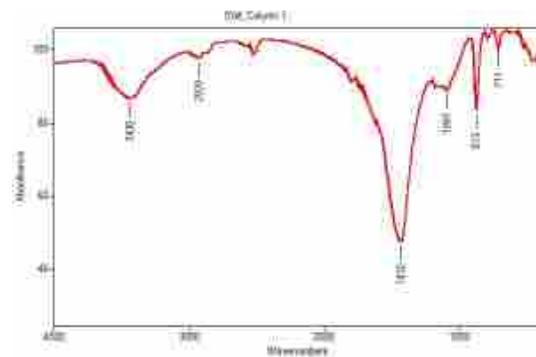
Figure 17: FTIR spectrum of the redbrick mortar sample

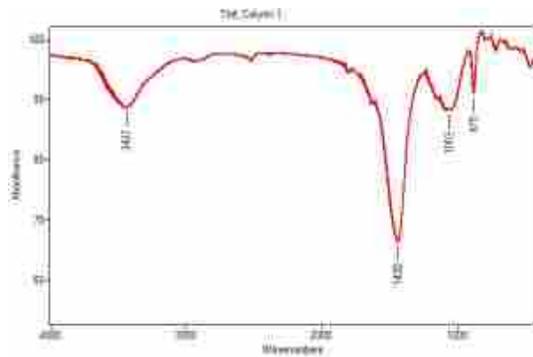
Figure 18: FTIR spectrum of the terrazzo mortar sample

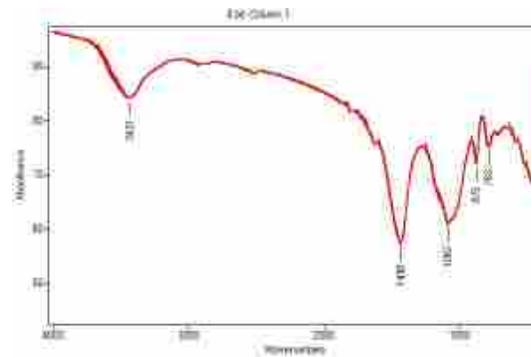
Figure 19: FTIR spectrum of a plaster sample from the palace

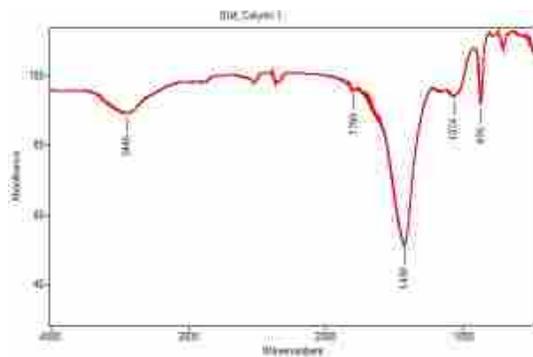
Figure 20: FTIR spectrum of a plaster sample from the marina

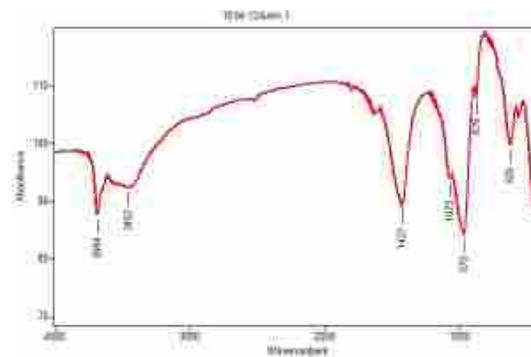
Figure 21: FTIR spectrum of a terrazzo sample from the palace

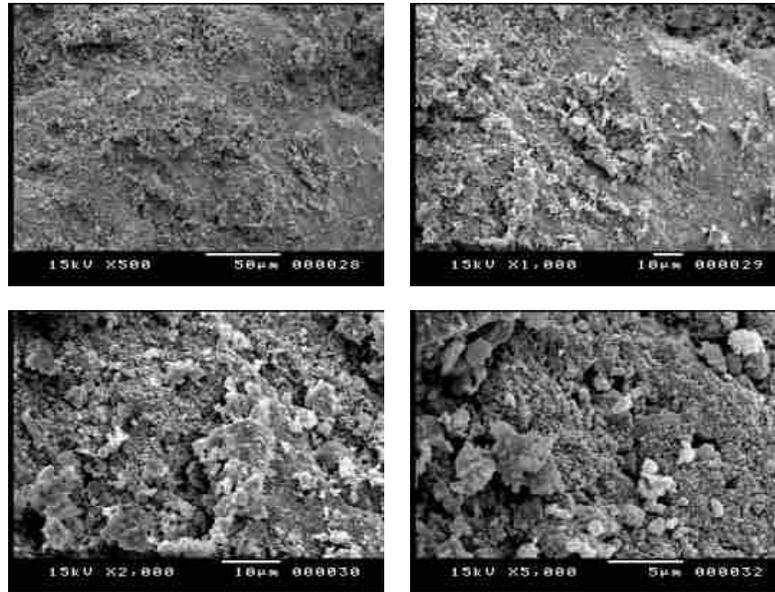
Figure 22: Scanning electron micrographs of the untreated mortar sample

**Nano Treatment Results:** Oriented untreated mortar sample was investigated by mean of SEM for comparison (figure 22); the examination proved that the mortar surface loses cohesion, while friability is clear in some points. Voids and gaps are also clearly seen on the mortar surface; these results make it obligatory to start in consolidation procedures.

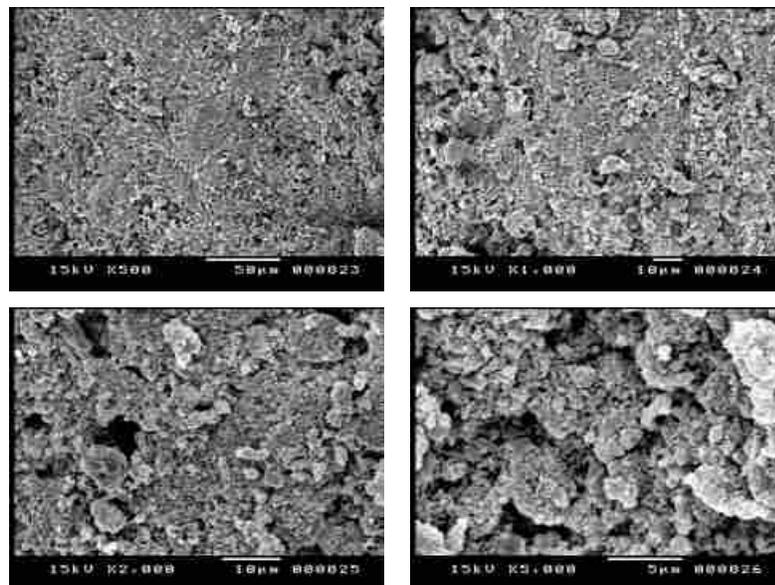
Figure 23: Scanning electron micrographs of the cement-lime mortar treated with nanolime

**Nanolime:** according to previous authors (addressed in the discussion); it has been mandatory to use water mixed with alcohol in dispersing nanolime. This solvent makes the solution more stable, in addition it provides long-term penetration into the treated building material due to the presence of water, the obtained results from using nanolime in consolidation of cement-lime mortars were disappointing; the SEM investigation has shown a deposited mass of nanolime on the treated surface, in addition; gaps and voids are still unfilled with consolidation material. It was also noticed that the adhesion between nanoparticles is lost and there is no correlation. Nanolime has appeared as divided agglomerates upon the treated surface (figure 23).

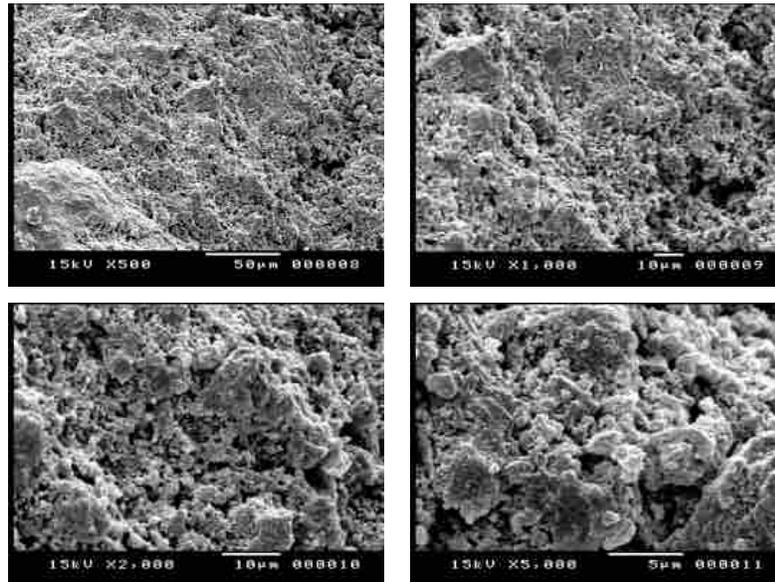
Figure 24: Scanning electron micrographs of the cement-lime mortar treated with nanotitanium

**Nanotitanium:** the results obtained from the SEM investigation are propitious (figure 24). Nanotitanium has formed a correlated porous film upon the treated mortar surface; the continuity of that film provides both consolidation and protection. This material can act as a preventive material, due to its antibacterial characteristics. Nanotitanium is an appropriate consolidant for mortars exposed to humidity and invaded by microorganisms.

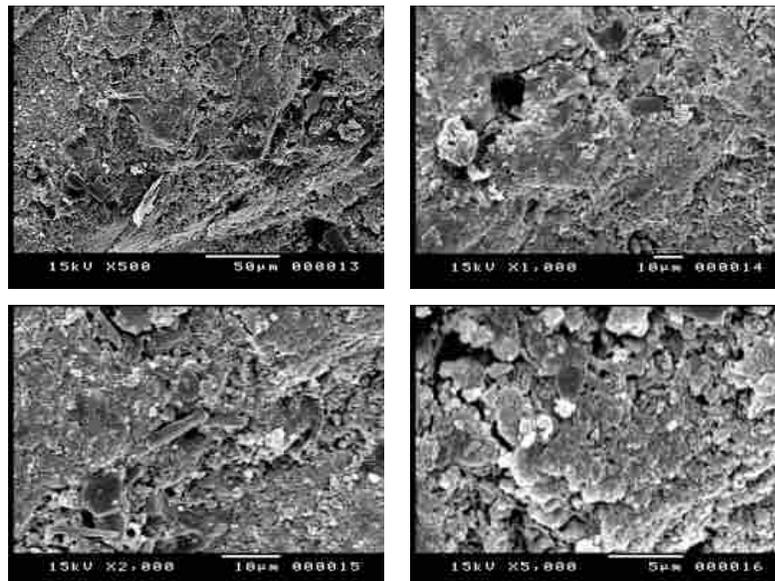
Figure 25: Scanning electron micrographs of the cement-lime mortar treated with nanokaolin

**Nanokaolin:** the results provided by the SEM proved that there is some lamina of nanokaolin deposited upon the mortar surface. These separated nanokaolin sheets were obviously detected (figure 25). Some gaps and voids were also detected upon the treated

mortar surface, thus; nanokaolin didn't provide the optimum desired results from the consolidation process.

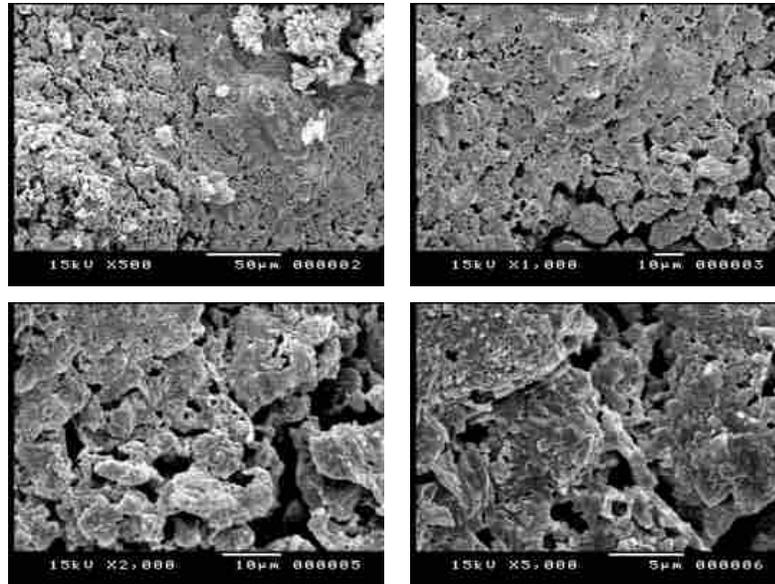
Figure 26: Scanning electron micrographs of the cement-lime mortar treated with nanosilica

**Nanosilica:** SEM investigation of the mortar sample treated with nanosilica dispersed in Paraloid proved that; although nanosilica has penetrated into cement-lime mortar, but Paraloid has agglomerated onto the mortar surface (figure 26). It has been also noticed that some nanoparticles were deposited upon the mortar surface, most of the previous studies (addressed in discussion) were achieved on the role of nanosilica in consolidation were related to concrete and modern fresh mortars. This study deals with ancient mortars and proves that nanosilica is not among the recommended consolidants for historical cement-lime mortars.

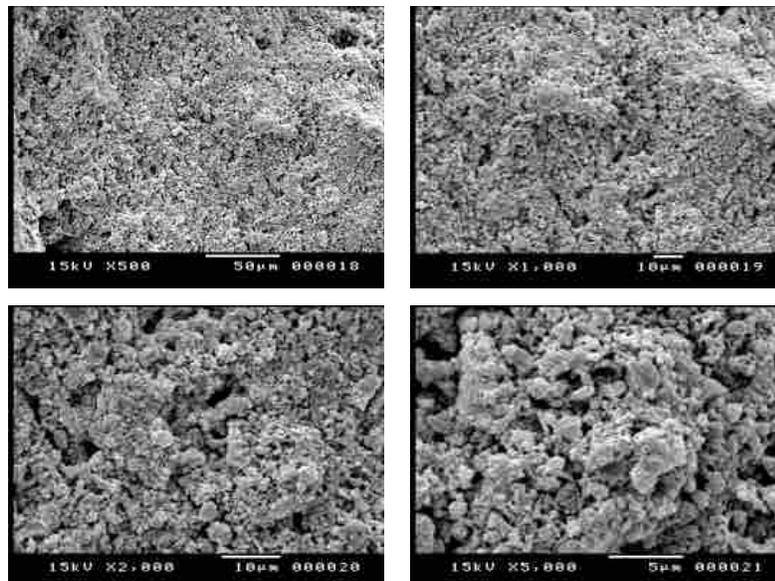
Figure 27: Scanning electron micrographs of the cement-lime mortar treated with multi-walled carbon nanotubes

**MWCNTs:** no evidence till now for the use of multi-walled carbon nanotubes as consolidant. The current study represents the first step in that trend. Polycarboxylate superplasticizer acts as a lubricant and a solvent, based on the data obtained from SEM (figure 27); it has been noticed that there is a sufficient penetration of the consolidant into the treated mortar. Moreover; a correlated porous film has been generated upon the mortar surface. This protective unseen (by naked eye) layer is fundamental for mortar breathability; it also enhances durability and doesn't affect the aesthetical appearance of the treated substrate. Thus; multi-walled carbon nanotubes is one of the recommended consolidants for cement-lime mortars at the royal palace of King Farouk.

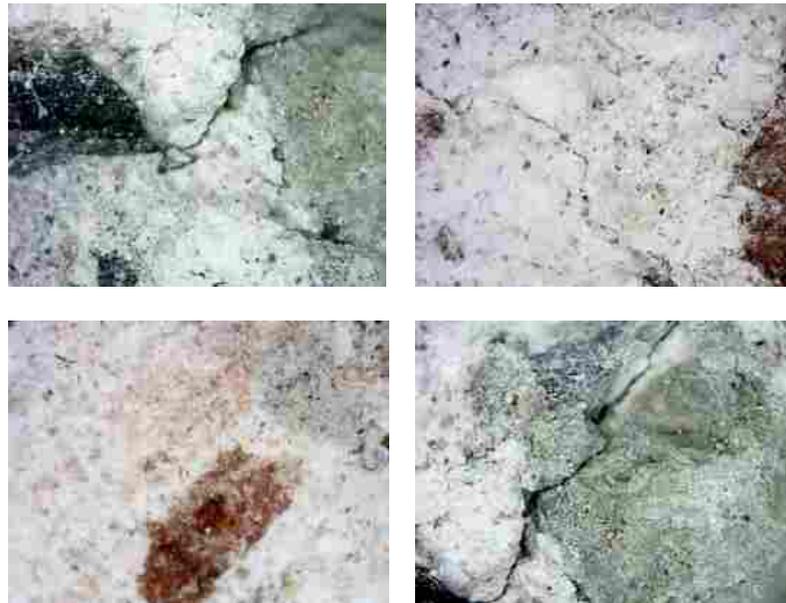
Figure 28: Four different shots taken by light optical digital microscope (500x) showing the aggregates (mainly crushed brick and carbon) added to the studied mortars

with crushed redbrick and pottery (used as bedding layer for terrazzo); albite refers to white Portland cement while hematite refers to crushed aggregates (figure 28).

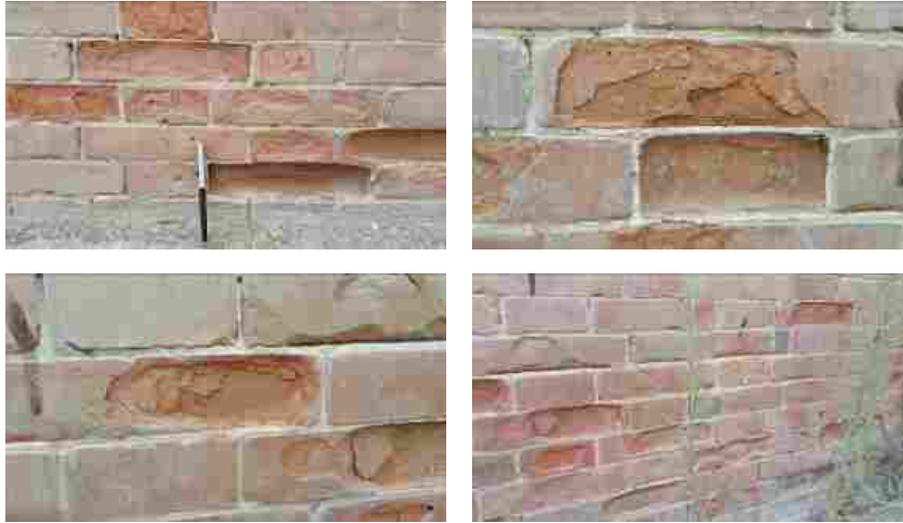
Figure 29: Shows the effect of soluble salts in conjunction with cement mortars and vegetation on the palace walls

Mortars consisting primarily of lime and sand have been used as an integral part of masonry structures for thousands of years. This basic formulation remained unchanged until the advent of Portland cement.<sup>22</sup> White Portland cement is sensitive to the attack of sulphates and sea water since calcium aluminates react with ( $\text{SO}_4$ ) Forming ettringite, moreover; cement mortars interact with atmospheric ( $\text{SO}_2$ ) forming gypsum and ettringite.<sup>23</sup> Traditional buildings have solid walls; without cavity or damp proof membrane, cement mortars are impervious to damp; and because cement is impermeable, moisture contained within the wall cannot evaporate through the mortar joint; instead it evaporates through the face of the masonry. Soluble salts then crystallize on the surface of the masonry causing premature crumbling of the face. Where a cement-based render is applied, water becomes totally trapped resulting in internal dampness.<sup>24</sup> High lime mortars are more permeable than denser cement mortars. Salt crystallization within a masonry unit creates pressure that can cause parts of the outer surface to spall off or delaminate. If the mortar does not permit moisture to migrate out of the wall and evaporate; the result will be damage to the masonry units.<sup>25</sup> External factors such as impermeable coverings also influence drying of masonry; the lower the concentration is, the deeper in walls the salt solution. Thus; weak salt solutions are able to cause remarkable damage in ancient constructions.<sup>26</sup> This phenomenon is widely visible in the Edfena royal palace, as the only way for the breathability of the building is through the masonry units themselves, thus; redbrick units are more degradable than the mortar joints (figure 29).

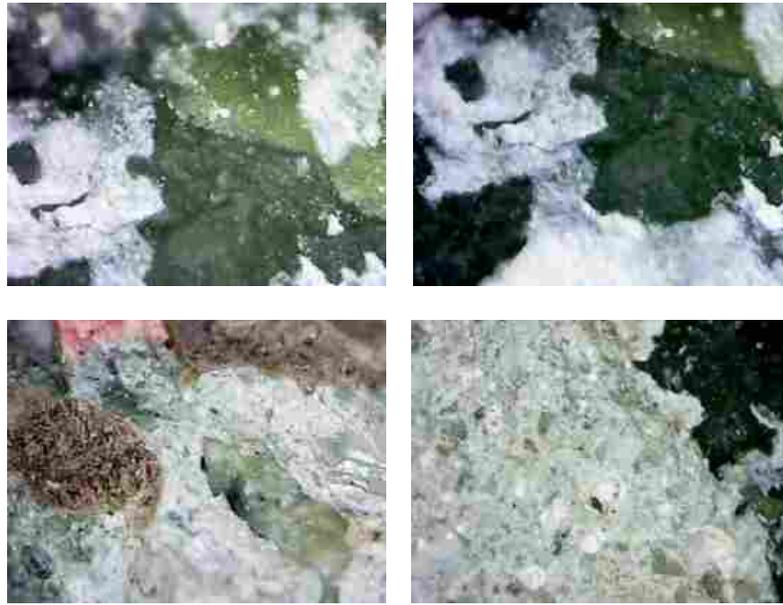
Figure 30: The terrazzo sample under light optical microscope (500x)

Terrazzo is a composite material consists of crushed limestone, quartz and pieces of granite, marble or glass cemented together in a mortar base.<sup>28</sup> This technique dates back to the 18<sup>th</sup> century in Italy and is derived from the "*Pavimento alla Veneziana*" technique, it is also related to the "*Seminato*" technique; while large pieces of marble are tossed into cement tiles and then polished.<sup>29</sup> Detection of portlandite and brucite is due to many factors, amongst; defects in the slaking process of lime, the final product could contain some crystalline CaO and MgO, the hydration reaction of CaO and MgO (to give portlandite and brucite) are expansive; causing cracks problems and break down of mortars.<sup>30</sup> Portlandite and brucite are normal components in ordinary Portland cement and white Portland cement; but their presence in our case study whether in mortars or terrazzo is indicator for a long-term thermal impact.<sup>31</sup> Terrazzo was prepared on the base of white Portland cement and dyed in order to obtain the green color effect; malachite mixed with greenalite was used as a pigment material; no previous evidences for this mixture in Egypt, moreover; no evidence for using malachite in the pharaonic wall paintings; this pigment became common since the Greco-Roman era; greenalite is a member of the serpentine clay group, it is supposed that it has been used here to get a light green color (figure 30).
